TOTAL AIRFRAME FATIGUE TEST F 104 G  
FINAL REPORT

Foreign Technology Division  
Wright-Patterson Air Force Base, Ohio

20 March 1975

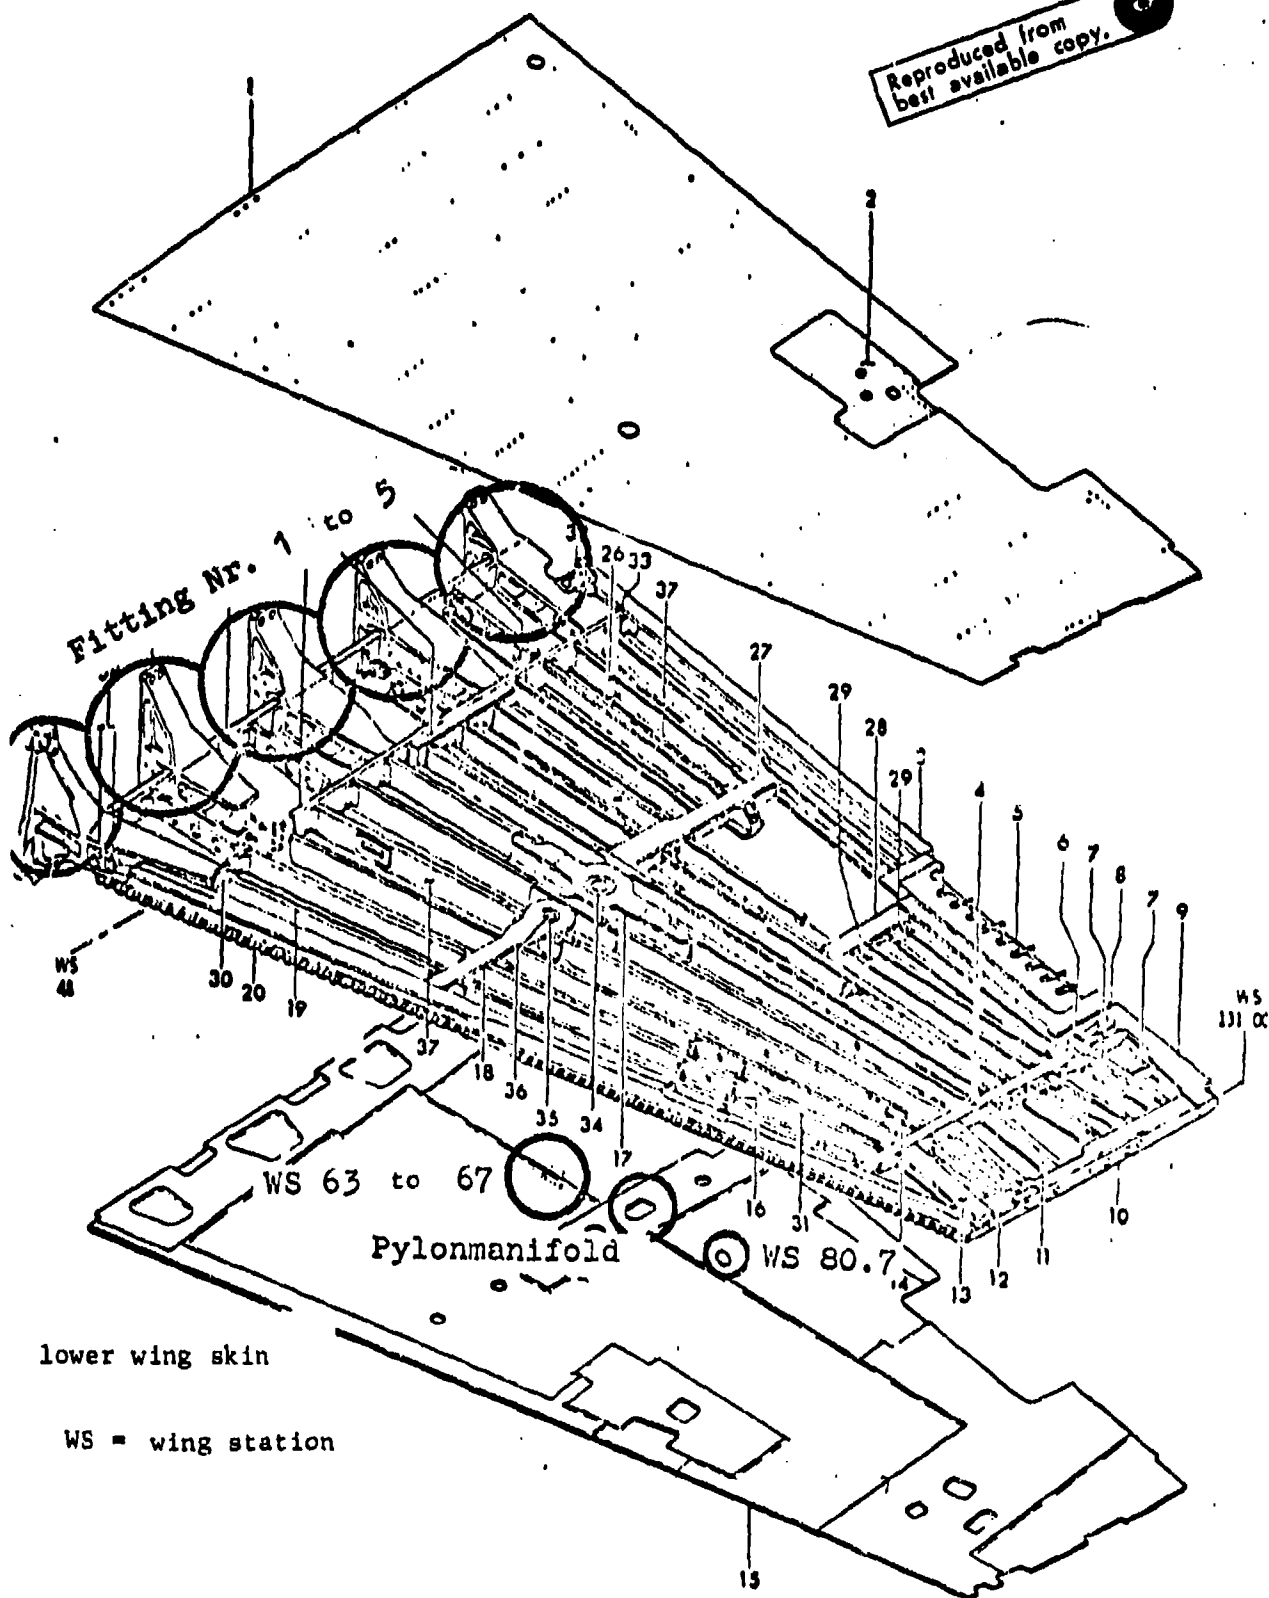
Figure 6. Summary of wing damage of category X.

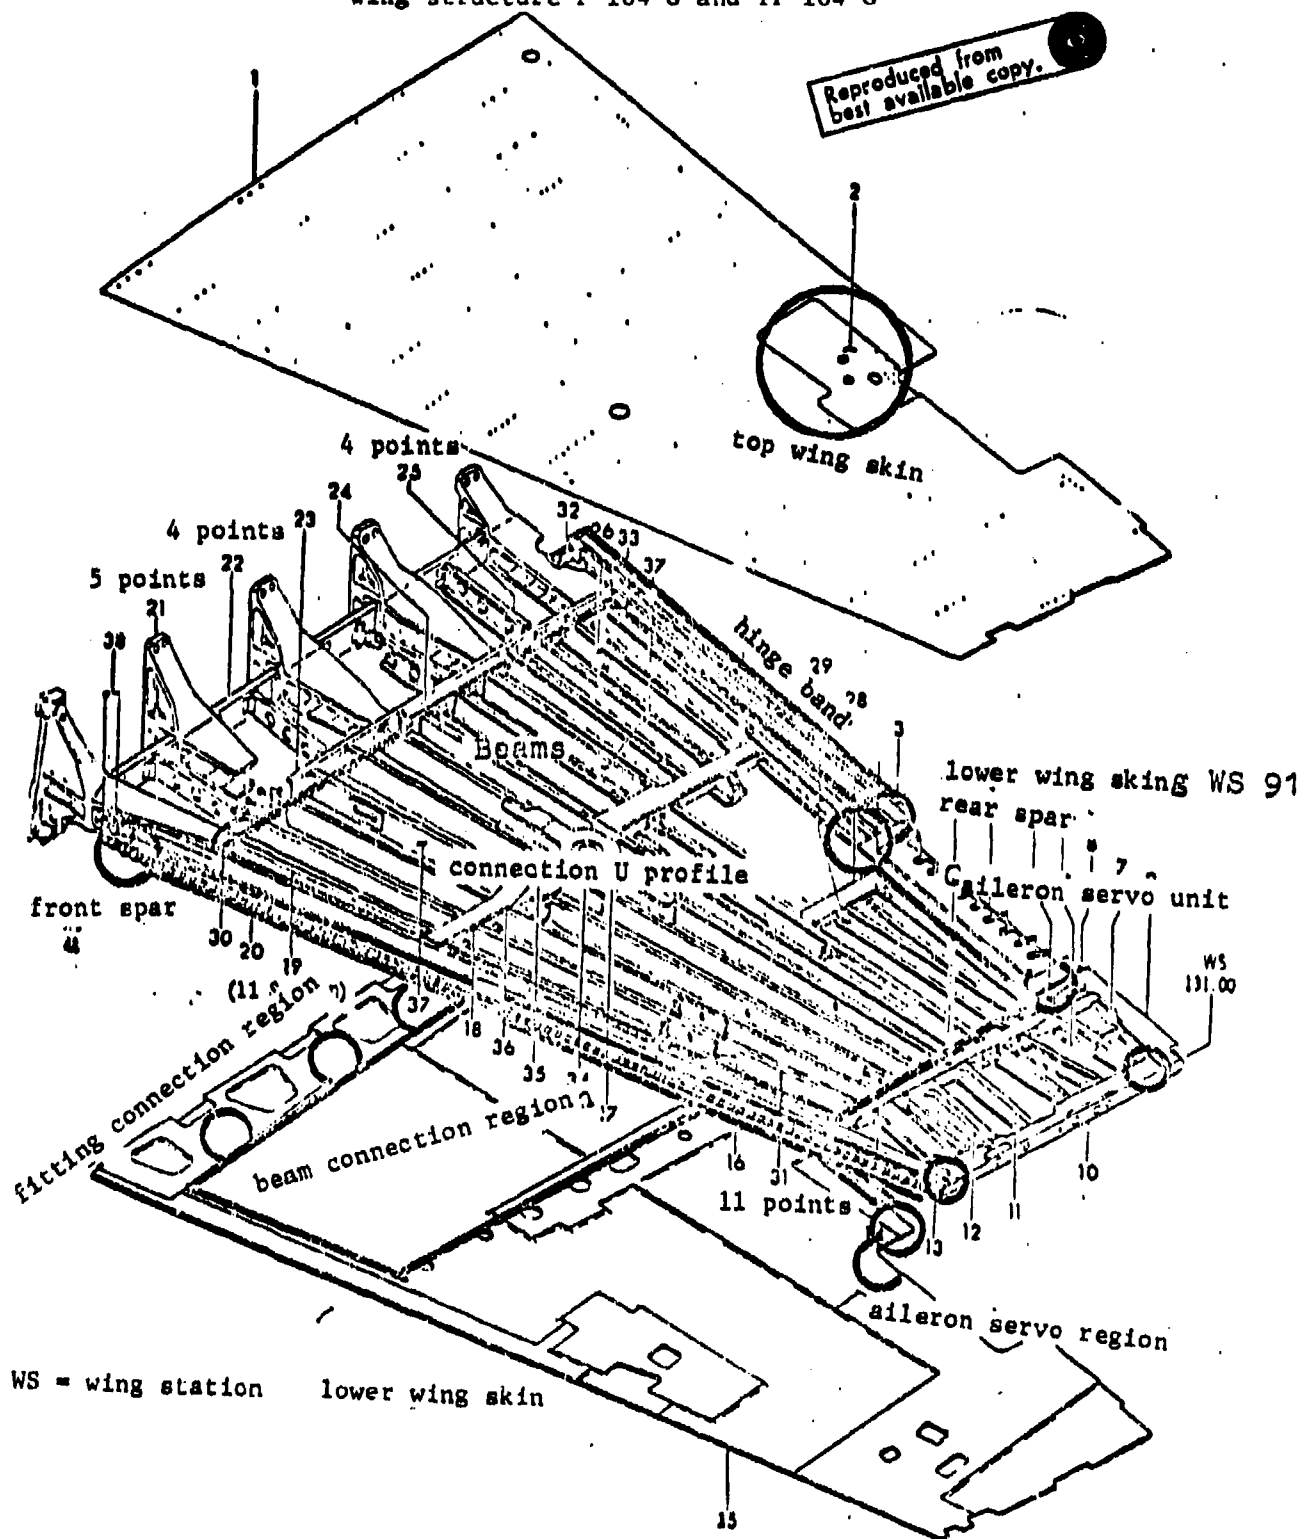
Figure 7. Wing damage summary, categories A and B.

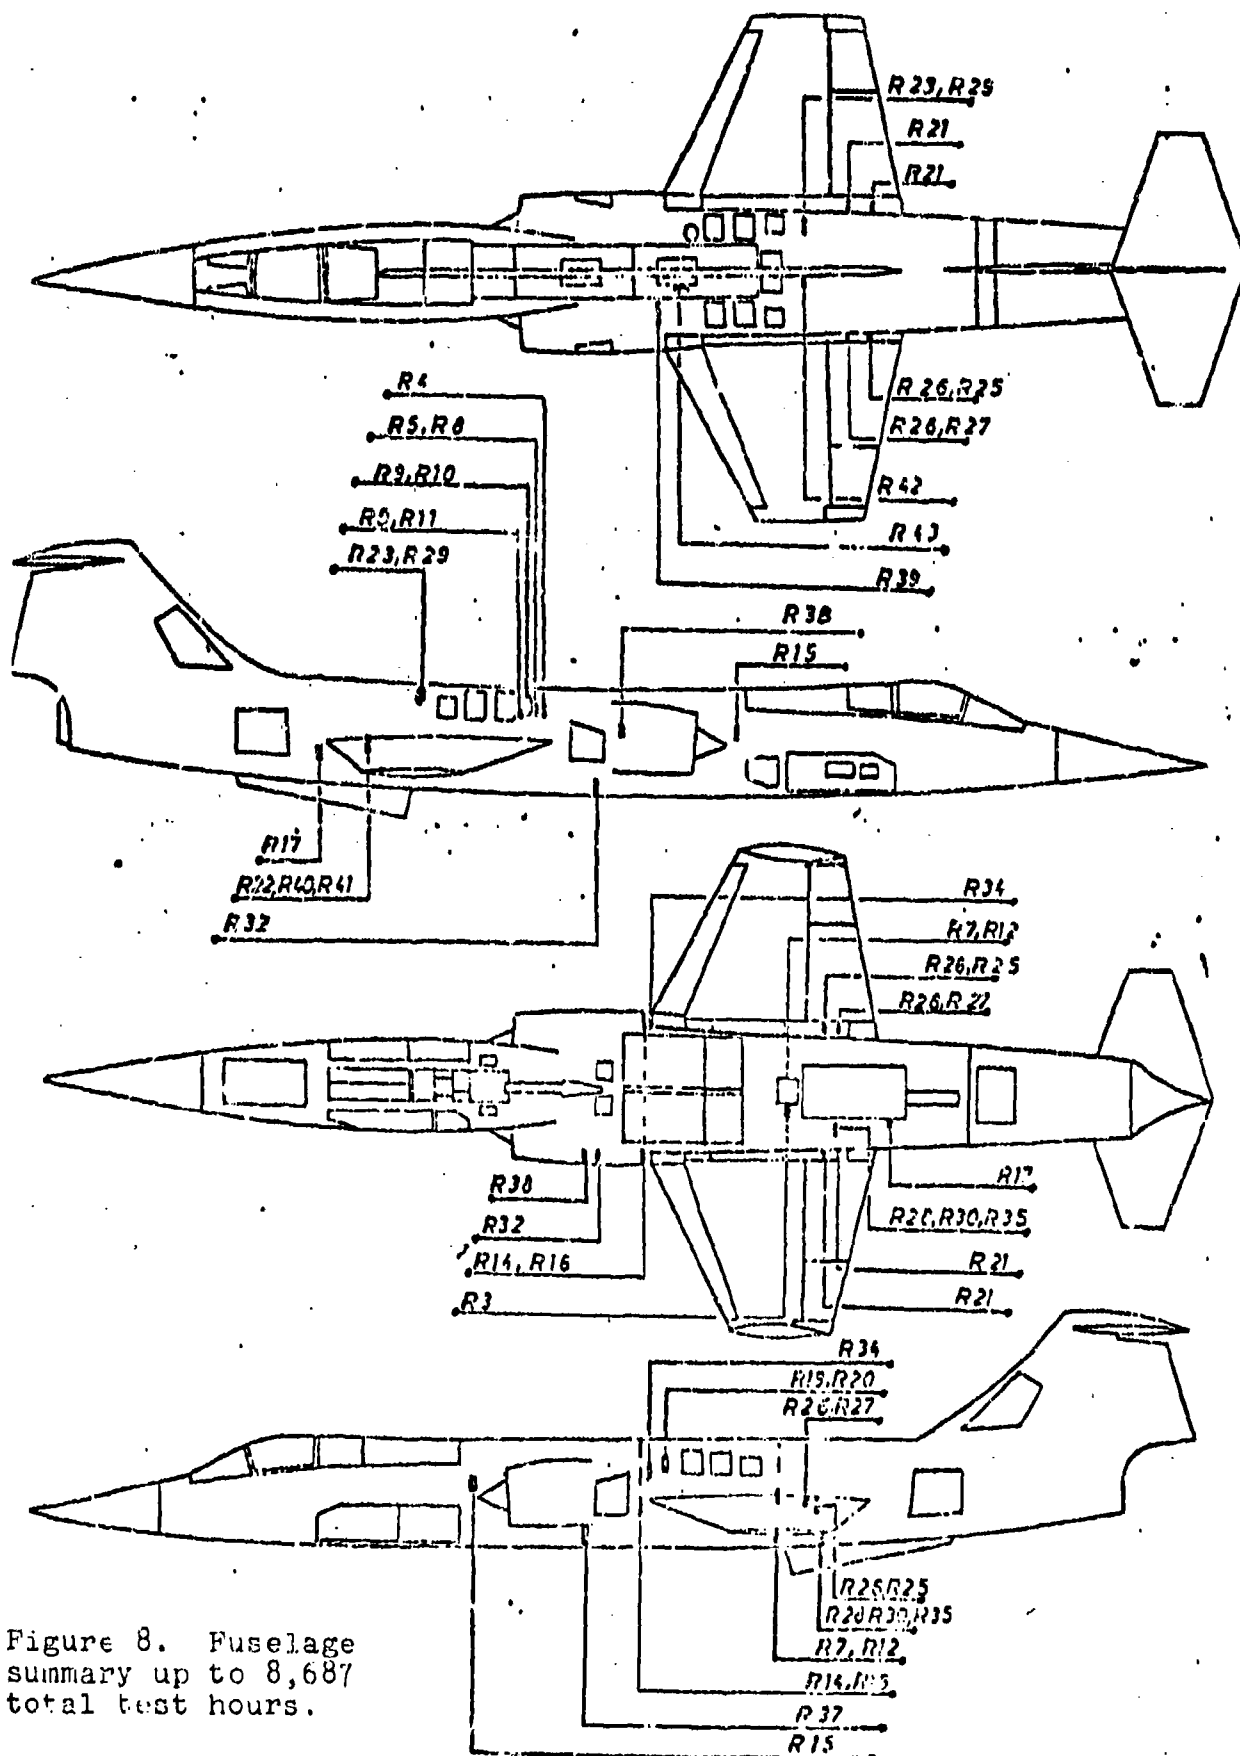
Figure 8. Fuselage summary up to 8,687 total test hours.

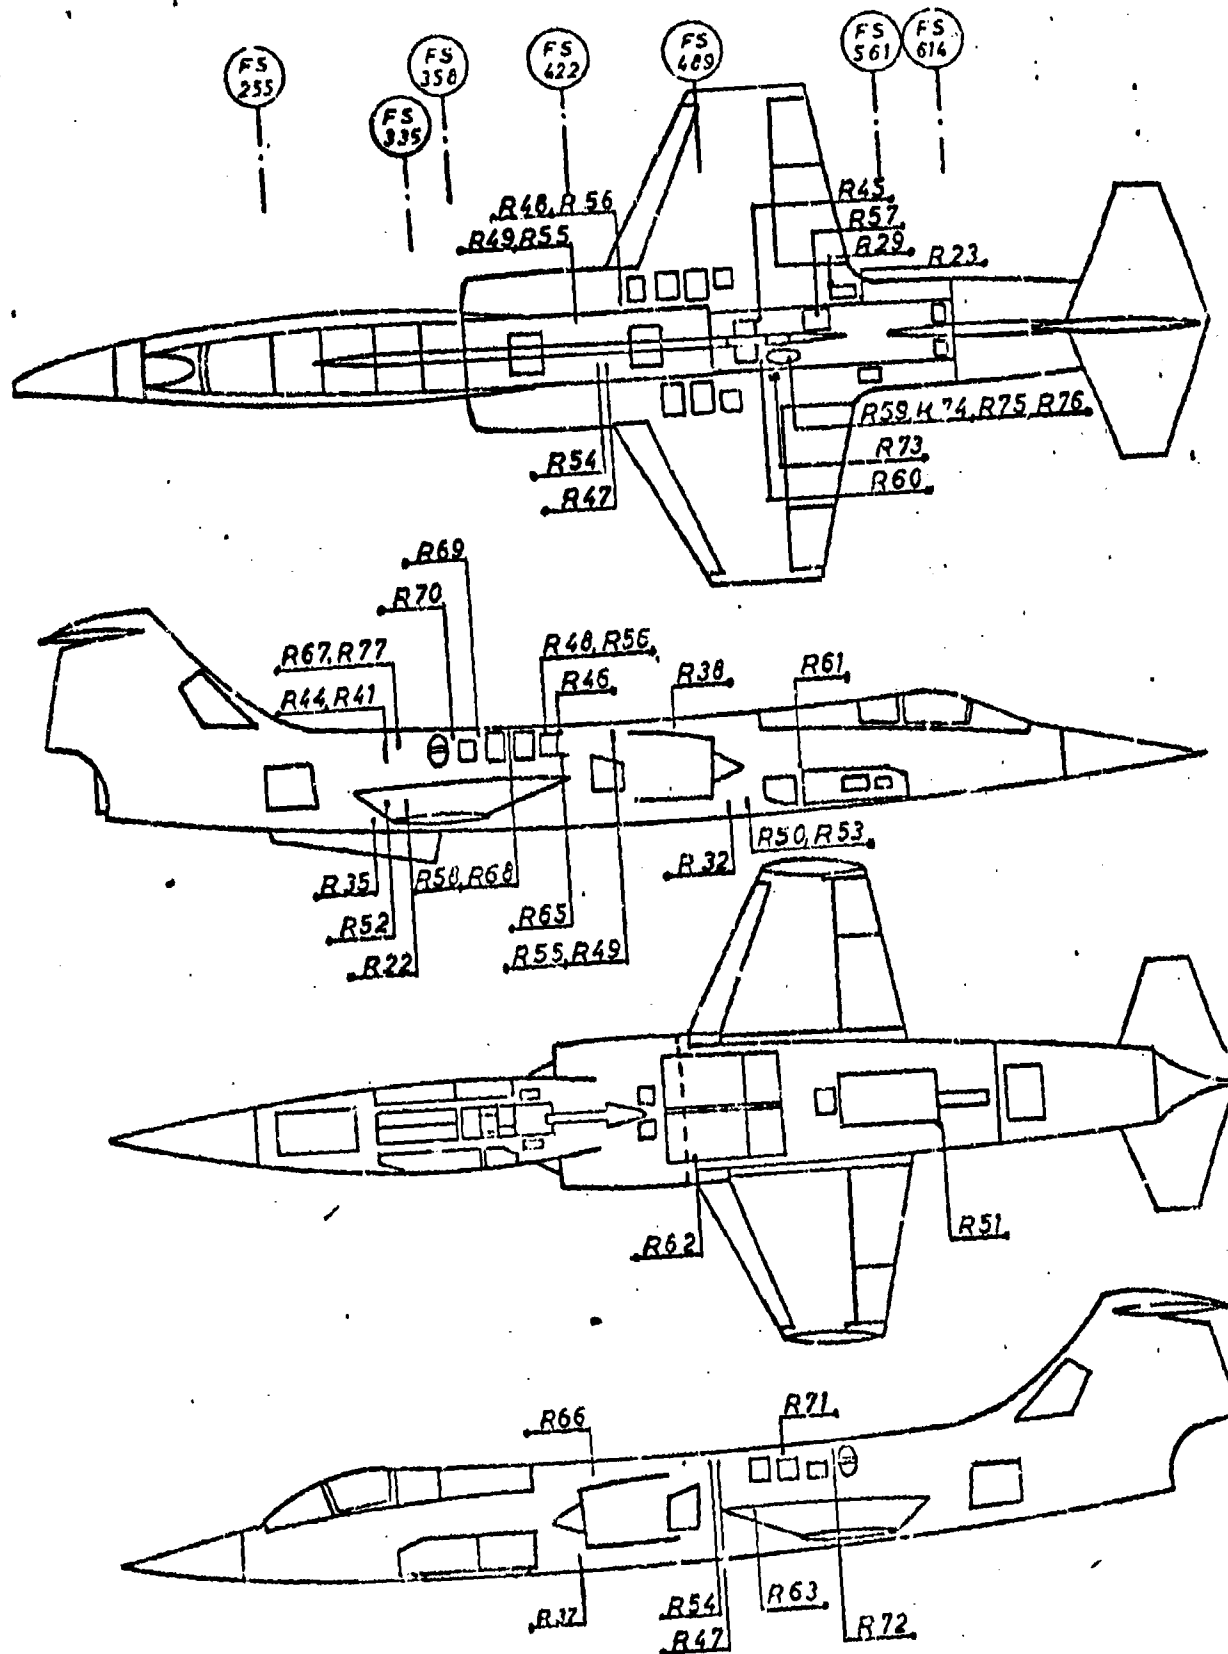
Figure 9. Fuselage damage summary between 8,687 to 14,869 total test hours.

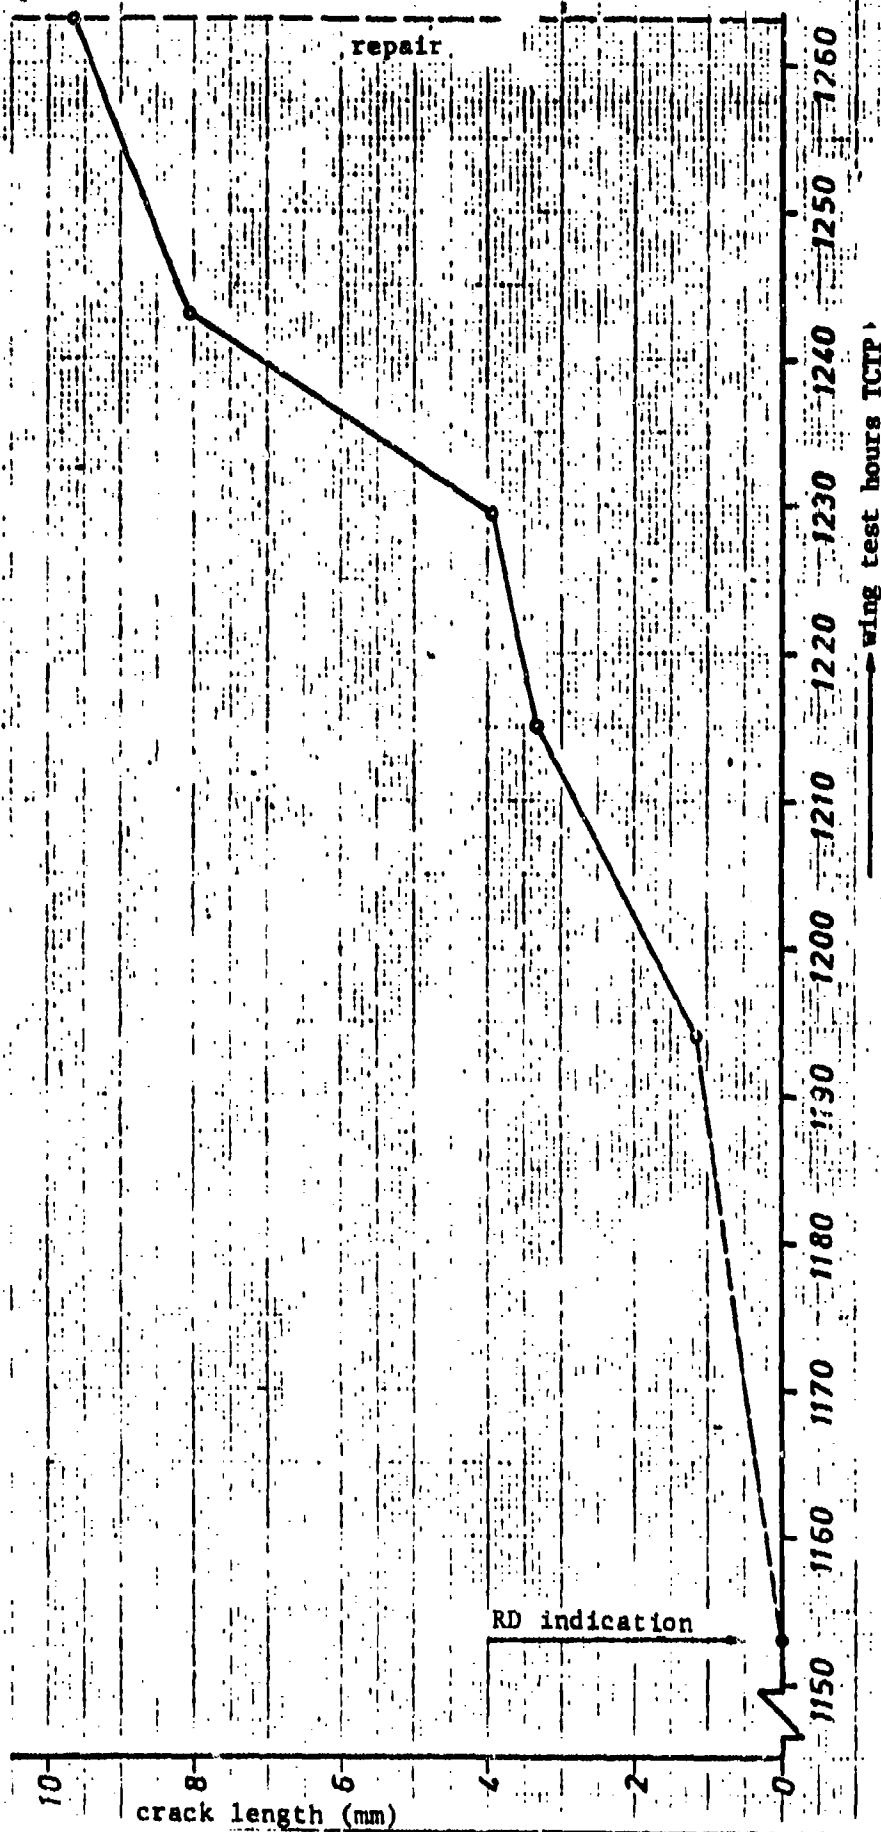
The damage was first established after about a calculated 1156 TCTP component test hours and propagated along a length of 10 mm (see Figure 10) up to 1,263 TCTP component test hours. A crack at a similar position in a troop aircraft stationed in the USA led to total damage. The openings mentioned have, in the meantime, been found to be superfluous because of construction changes and all lower wing skins are now being closed in succession, or these openings are no longer made in new surfaces.

Figure 10. Crack advance variation for opening at the aileron servo. Damage No. F1 (right wing lower side, WS 80.7).

— Special measures were taken early for the critical damage in the lower skin of the wing assembly in the region of the aileron servo (WS 80.7), which occurred very early during the fatigue experiment (see point 4.4.3) and which led to the loss of an aircraft at Luke.\*

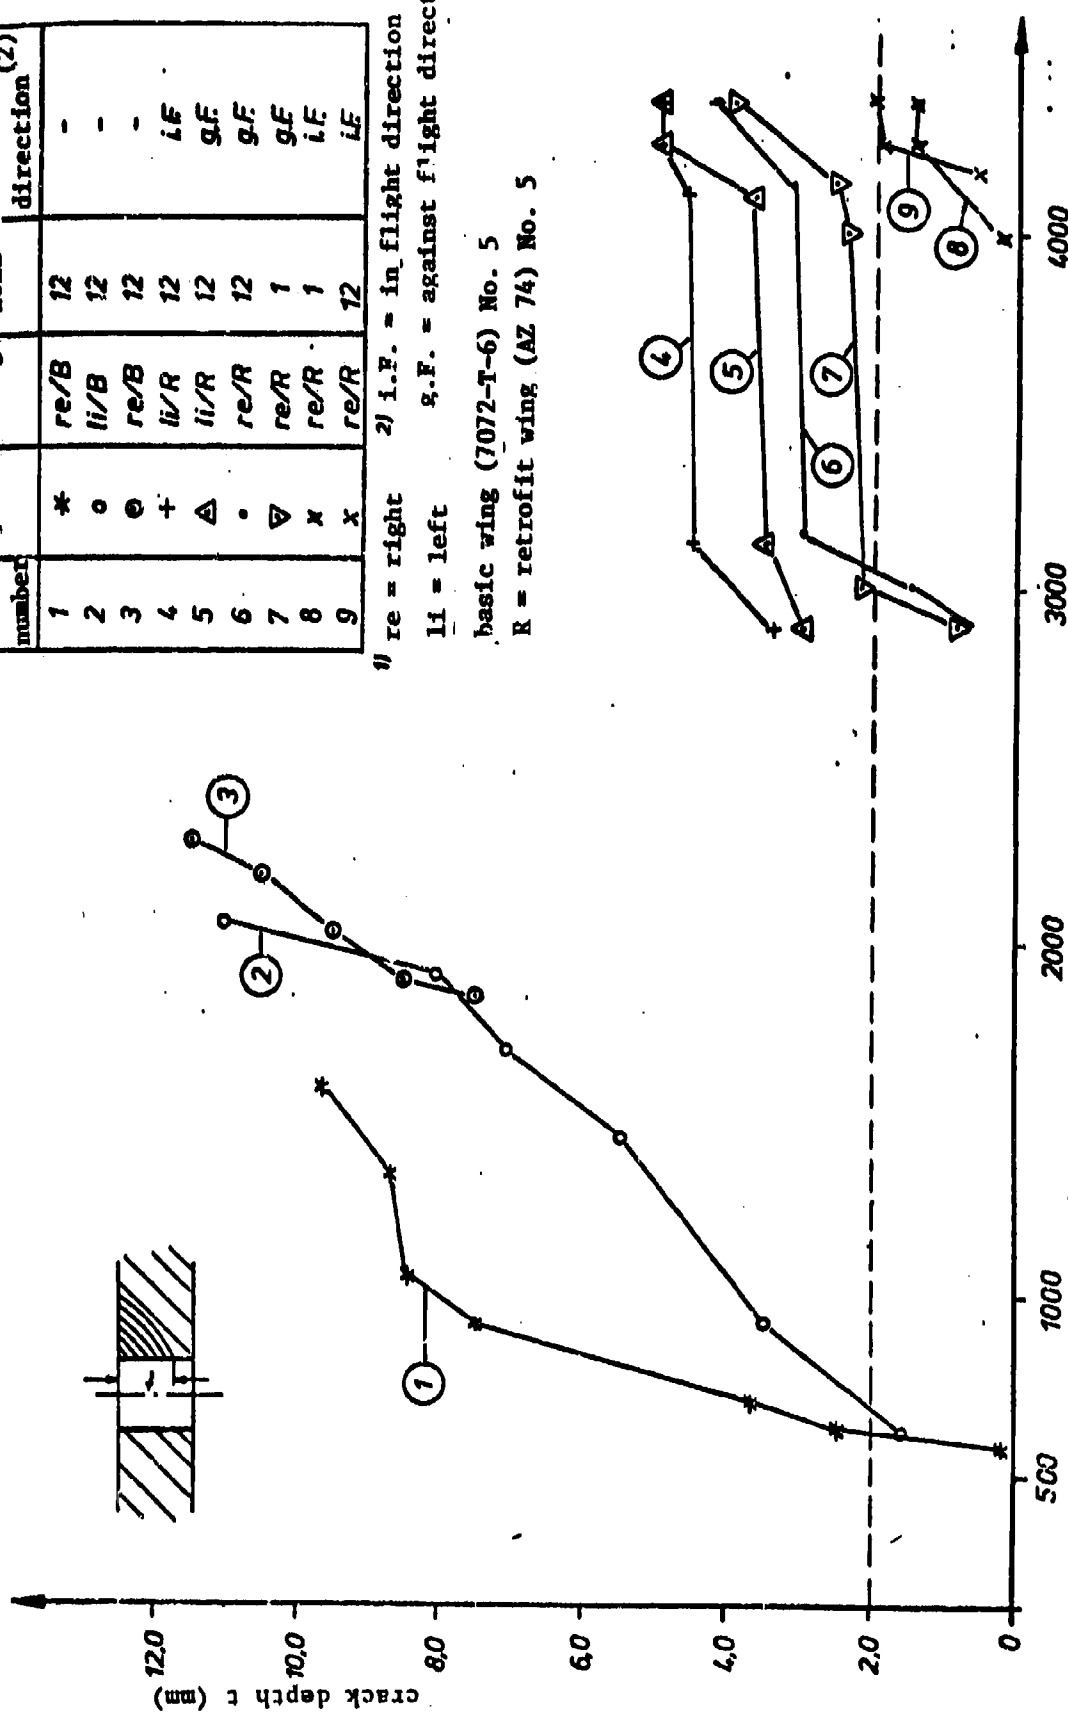
Figure 11. Crack propagation fitting No. 5 AZ 74.

During the total airframe fatigue test with the basic wing, in addition to a large number of fatigue cracks, we found four total fractures in a total of 31 fittings. Of these total fractures, three occurred in fitting 5 after 1,728 2,246, and 2,280 TCTP component hours, respectively, as well as a consecutive fracture in fitting 4. The most significant cracks and fractures occurred primarily in the first hole rows on the side of the fuselage. After modifying the fittings (material change from 7079 or 7075, respectively, to AZ 74, thickening of the flange, and widening) within the framework of the retrofit program, we find a considerable improvement in the fatigue properties (see Figure 11).

— In addition to the damage mentioned above at WS 80.7, the wing connection fittings and especially fitting No. 5 must be considered as critical components. Therefore, special measures were formulated for these relatively early. The fittings were investigated for initial cracks in the critical hole 12 using a special eddy current method developed by the IABG. In these investigations, we detected initial cracks in a number of fittings before the maximum operational time interval for these components had been reached, which is fixed at 1500 flight hours (exchange within the framework of the retrofit program). Just as before, the fittings should be immediately exchanged in such cases.

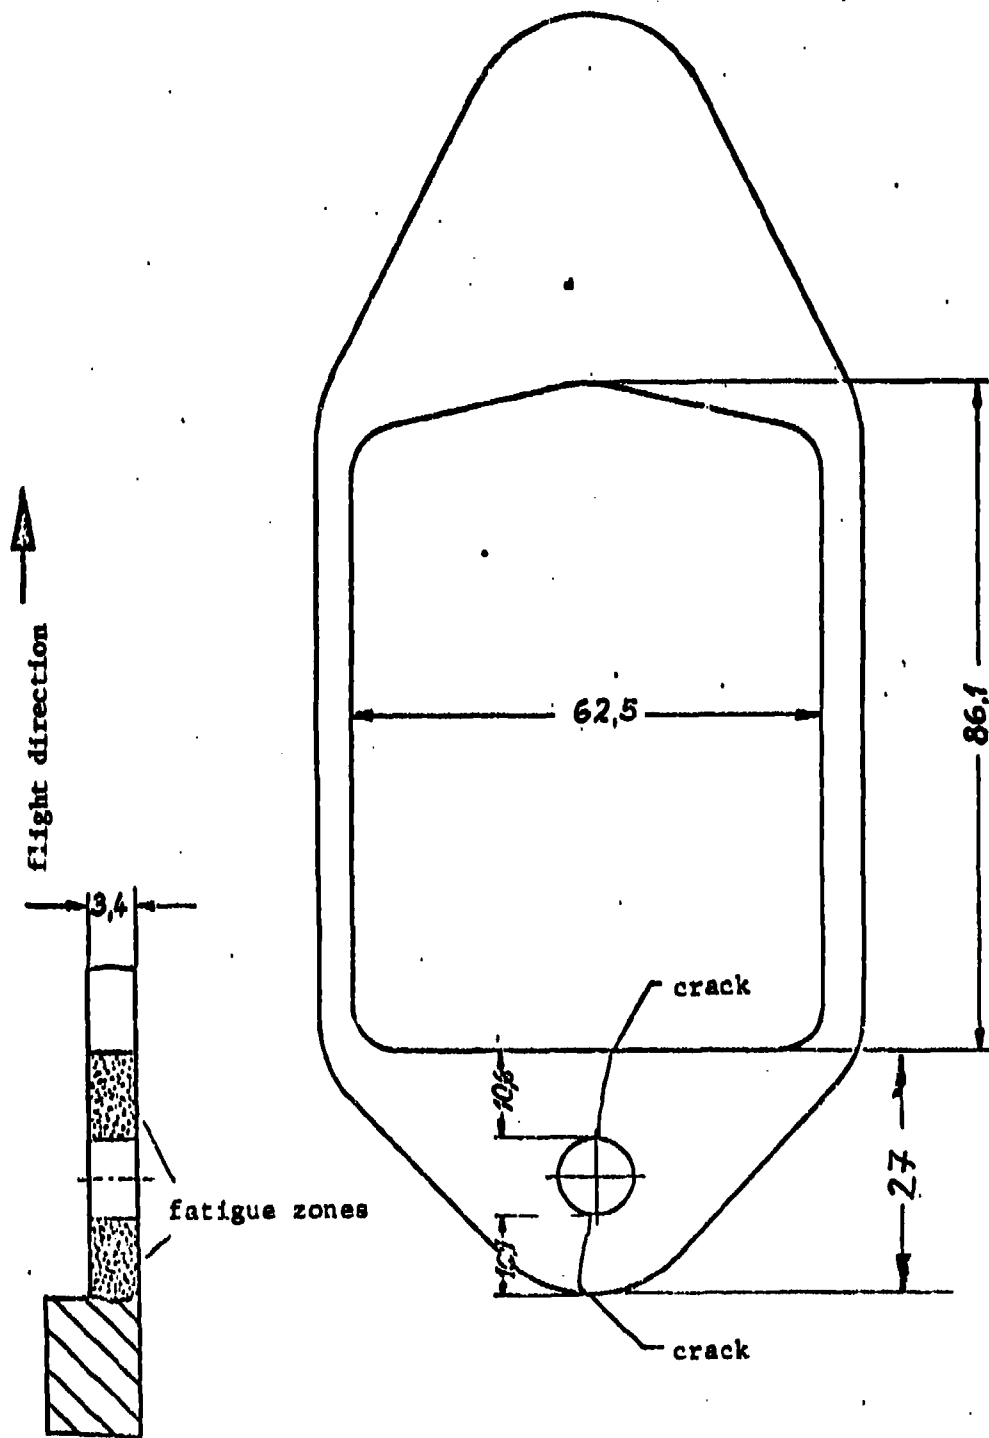
At 4,971 TCTP wing test hours, we detected a crack with a total length of about 27 mm (see Figure 13) at the attachment hole for the fuel connection cover in the lower wing skin of the basic wing. After 4,015 TCTP wing test hours, we found cracks with a length of 0.5 to 2.5 mm in the region of the attachment holes at the left and right retrofit wings. These became enlarged up to the end of the experiment after 14,869 total test hours, corresponding to 6,182 TCTP component test hours, up to 10.3 mm. The skin thickness in this region is the same for the retrofit wing and the basic wing.

Figure 13. Small crack in the holes on the pylon manifold at WS 74 for the basic wing for 4,971 TCTP wing hours.
